Height Control Valve

Thank you for purchasing a reconditioned height control valve from us.

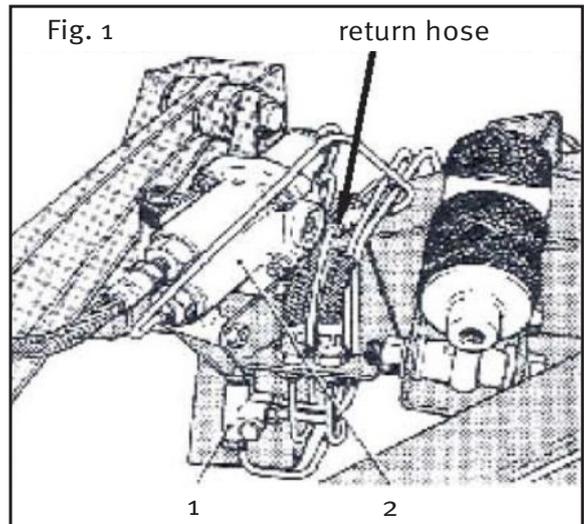
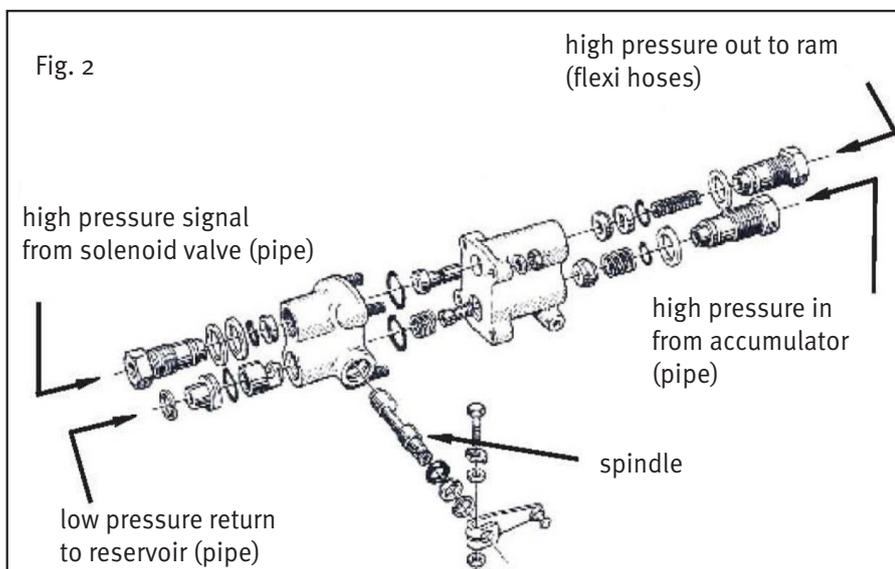
1. You have replaced the low pressure return hose which we have supplied (CD6244P). Please see the diagram (Fig 1) and take care to ensure that the hose you replace is the return hose to the body (situated on the LHS of the car) NOT the hose that comes out of the valve itself.
2. It is also common to fit the high and low pressure pipes that go into the front of the valve into the wrong ports on the valve. This will cause a build-up of pressure in the valve. Please take great care to ensure that these pipes are refitted correctly.

3. The valve has been left with the spindle in the Neutral position. If you turn the spindle through more than 45 degrees in either direction then it will disconnect internally causing the valve to fail.

Exchange valves will only be refunded if the housing of the valve, in particular where the low pressure port is held in by a circlip, is not damaged. When there is a build-up of pressure in the valve it will usually cause this port to blow out damaging the casing.
